A RESOLUTION ACCEPTING A REPORT ON  
BENTHIC MACROINVERTEBRATE SURVEYS IN BOLIN CREEK  
Resolution No. 91/2006-07

**Benthic Macroinvertebrate Surveys in Bolin Creek from Carrboro, North Carolina  
(August 2006)**

## Town of Carrboro Planning Department

Date: December 5, 2006 – Corrected on 12/6/06 *WJA*  
 To: Mayor and Board of Aldermen  
 Copy: Steve Stewart, Town Manager  
 From: D. Will Autry, Environmental Planner  
 Subject: Bolin Creek Benthic Macroinvertebrate Survey Report

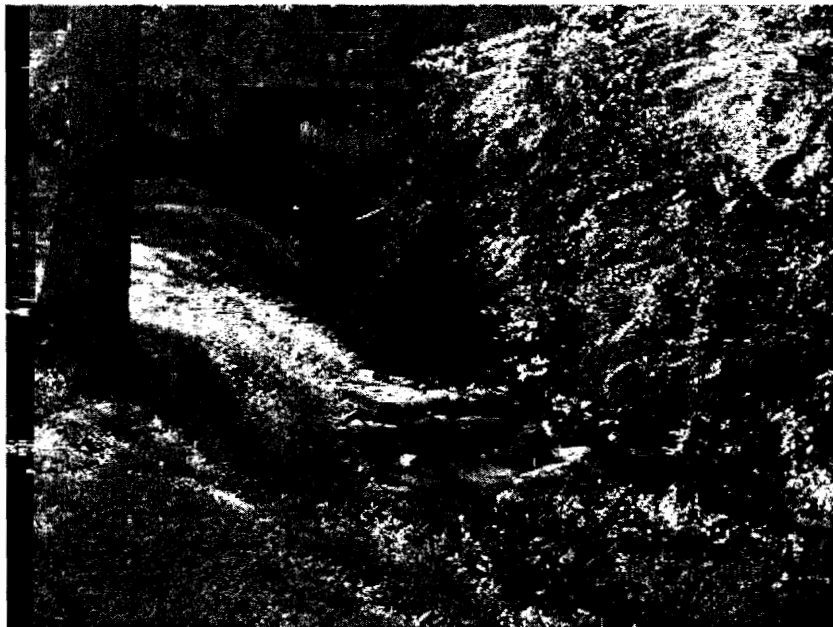
Photo 2. Bolin Creek near SR 1777

SR 1777 crossing at Bolin Creek - This site is located upstream of the SR 1777 bridge crossing of Bolin Creek (**Photograph 2**);

- 2a). Quarterly benthic surveys (EPT taxa richness) should be initiated at the SR 1777 site to insure habitat degradation does not spread downstream to this site.

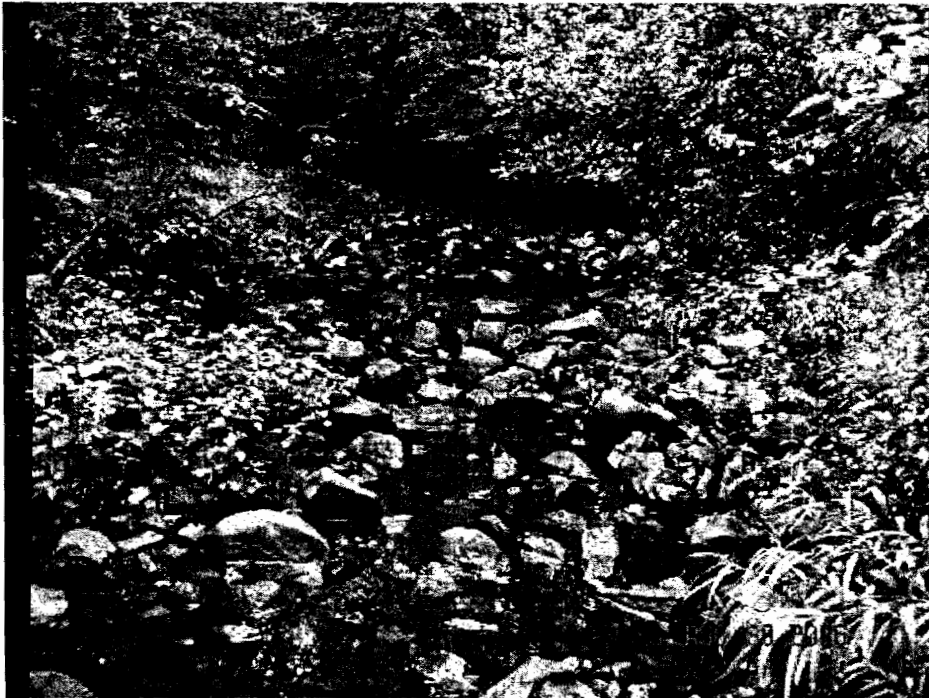
Photo 3. Bolin Creek near Waterside Drive

Waterside Drive near Bolin Creek - This site is located near Waterside Drive. The site is accessed along a power line right-of-way easement adjacent to residential properties along Waterside Drive (**Photograph 3**);

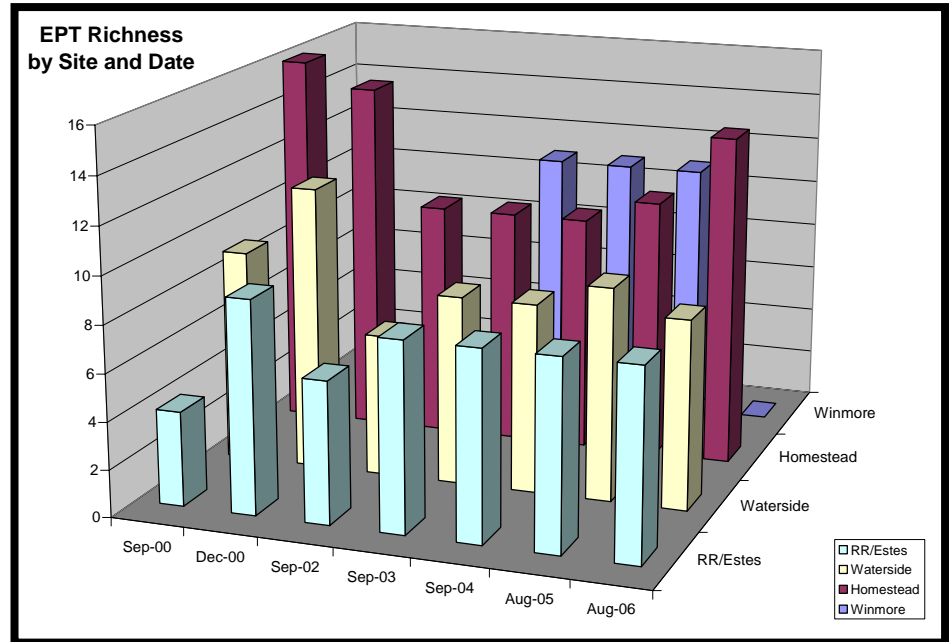
This chart shows the EPT Richness of all survey events. "EPT" is a group of three orders of insects (Ephemeropter [mayflies], Plecoptera [stoneflies], and Trichoptera [caddisflies]) which are sensitive to pollution and are strong indicators of a stream's health. "EPT Richness" is the number of EPT taxa in a sample.

As these figures show, since recovering from the drought of 2002, excluding the sample at Winmore in 2006, the EPT richness and biclassification rating are quite static. This indicates that water quality in the sampled segment of Bolin Creek appears to be stable.
